Report No. 460,353 /2

Assignment: Impact tests on safety strips for protruding reinforcement bars

Object of investigation: Safety strips with the brand name NEVO SAFE-PLUS®
Customer reference:
Your order dated: 12/03/2012
Receipt of test objects: 30/03/2012 and 27/04/2012 (safety strips)
Test conducted on: 30/03/2012 and 27/04/2012
Number of pages: 8
Attachments: -

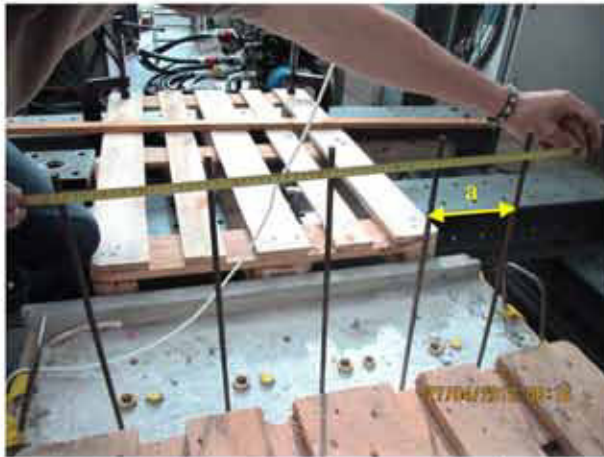
a) Arrangement of reinforcing bars, \varnothing 8 mm
 $n=5$, $a=150$ mm, $L=450$ mm

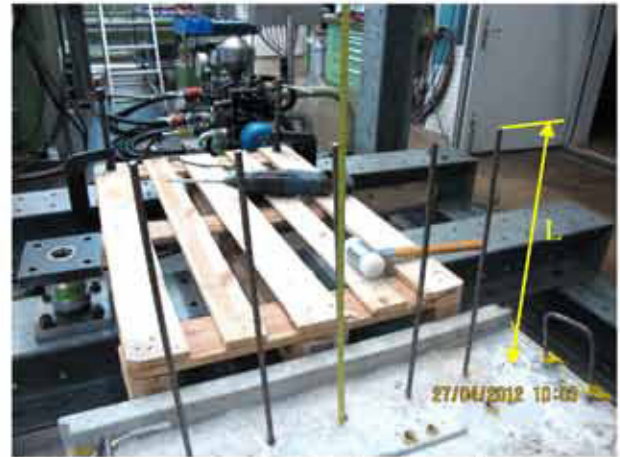
b) Arrangement of reinforcing bars, \varnothing 10 mm
 $n=5$, $a=150$ mm, $L=500$ mm

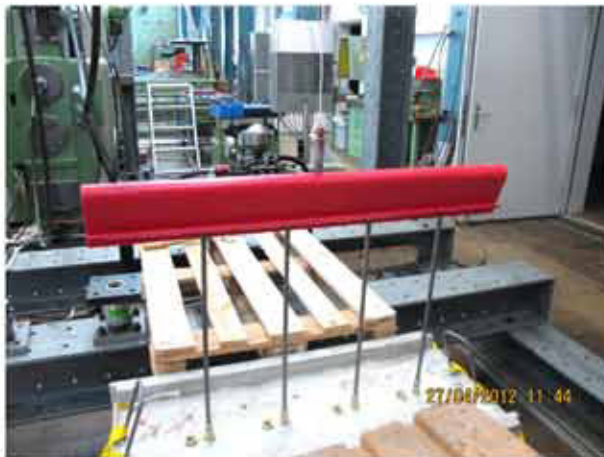
c) Arrangement of reinforcing bars, \varnothing 12 mm
 $n=4$, $a=200$ mm, $L=670$ mm

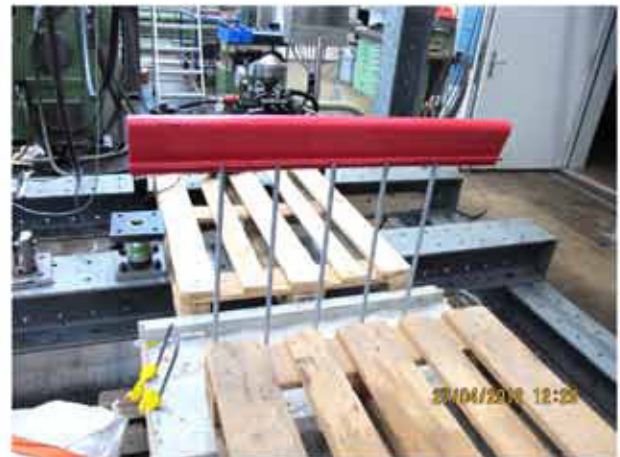
d) Arrangement of reinforcing bars, \varnothing 14 mm
for V01-14, $n=5$, $a=150$ mm, $L=650$ mm

- Nominal dimensions of sandbag (length x width x height; rounded mean values):
 - For reinforcement bars $\varnothing 8 - 14$ mm: 600 mm x 600 mm x 300 mm, see Fig. 4/d

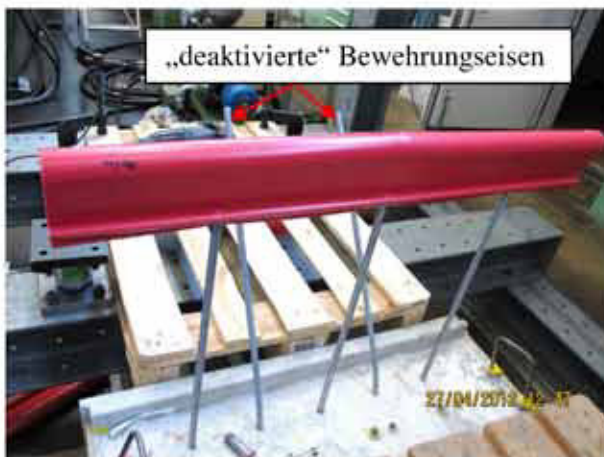
[Legend:
„deaktivierte“ Bewehrungs-eisen: “deactivated”
reinforcement bars/
e) Arrangement of reinforcing bars, \varnothing 14 mm
for V02/03/04-14, $n=3$, $a=300$ mm, $L=650$ mm

- For reinforcement bars $\varnothing 16$ mm: 600 mm x 400 mm x 350 mm, see Fig. 2/e
- Alignment of sandbag to safety strip: Contact on impact close to the long axis of symmetry of the bottom of the bag (slight scatter due to horizontal offset and rotation of the sandbag during free fall).

- a The same strip as in the previous test, but offset by 100 mm (as seen in Fig. 4/f)
The other tests were carried out with unused safety strips.
- b 5 reinforcement bars, spacing 150 mm
- c 3 reinforcement bars, spacing 300 mm (2 bars from Test V01-14 deactivated, Fig. 2/e)

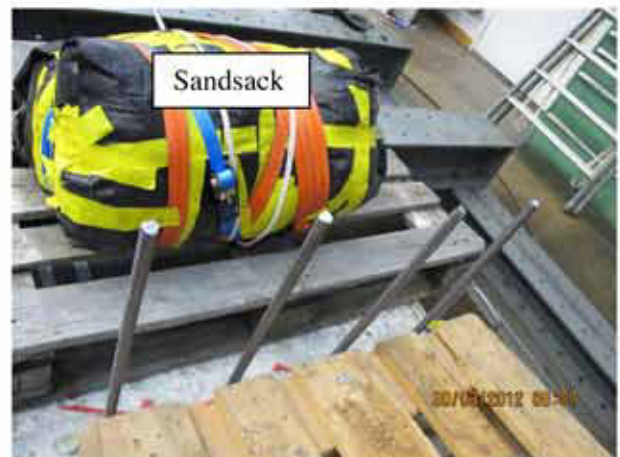
Fig. 2: Arrangement of reinforcement bars according to diameter.

[Legend:
Sandsack: Sandbag/
f) Arrangement of reinforcing bars, \varnothing 16 mm
 $n=4$, $a=200$ mm, $L=520$ mm

n: Number a: Nominal spacing L: Free length

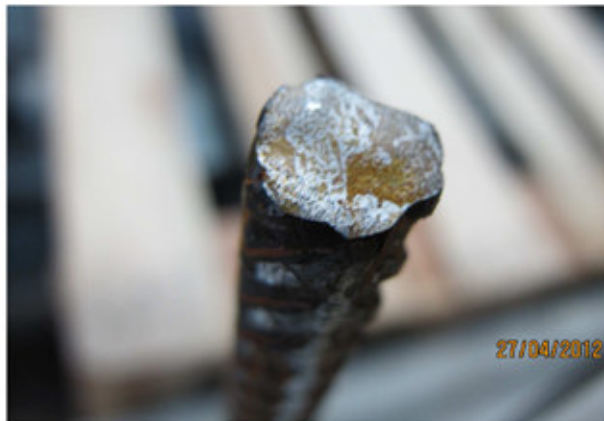
a) Reinforcing bars, $\varnothing 10$ mm

Fig. 3: Two typical examples of sharp-edged, cut ends of reinforcement bars

- Form of ends of reinforcement bars: Slightly oblique, sharp-edged cut surfaces, Fig. 3 (typical “worst case” in actual practice). Reinforcement bars that had been significantly bent by the impact were replaced before the next test (Table 2).

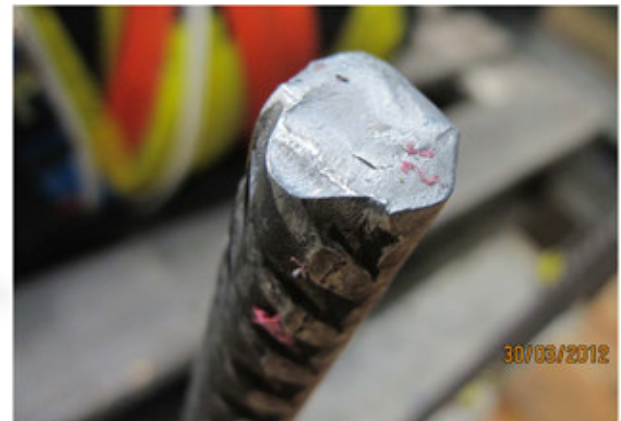
b) Reinforcing bars, $\varnothing 16$ mm
(Photo taken after 10 impact tests)

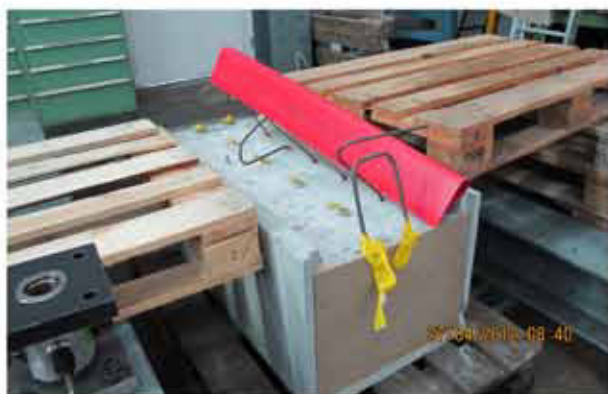
a) Test V01-08 (bar $\varnothing 8$ mm)

Fig 4: Typical evidence of damage depending on the diameter of the reinforcement bars (bar: reinforcement bar).

Fig. 4 shows the damage typical of each diameter of reinforcement bar. In the tests with bars of $\varnothing 8$ and $\varnothing 10$ mm, the reinforcement bars buckled significantly. In some cases, the plastic cover of the protective strip received localised damage in the form of cracks or plastic deformation. In the case of reinforcement bars of $\varnothing 16$ mm, the steel inset was ruptured at individual points of contact with the tips of the bars; in all other cases, there was only a more or less well-defined pressure point (imprint of the tip of the bar), coupled with local plastic deformation of the steel inset. **In none of the tested cases would a construction worker – as simulated by the sandbag – have been injured by impalement.**

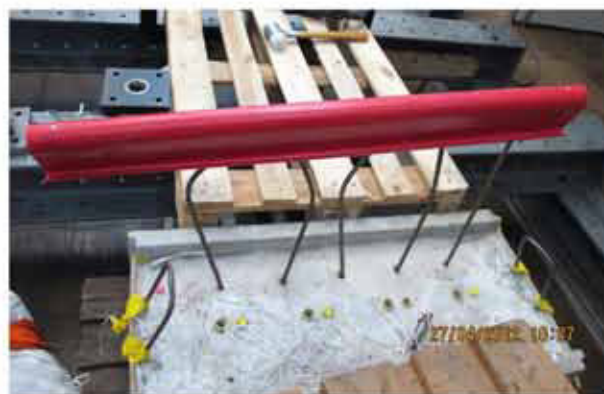
b) Test V02-10 (bar $\varnothing 10$ mm)

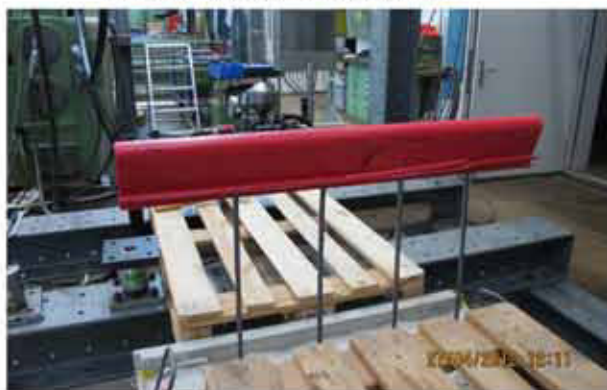
c) Test V03-12 (bar $\varnothing 12$ mm)

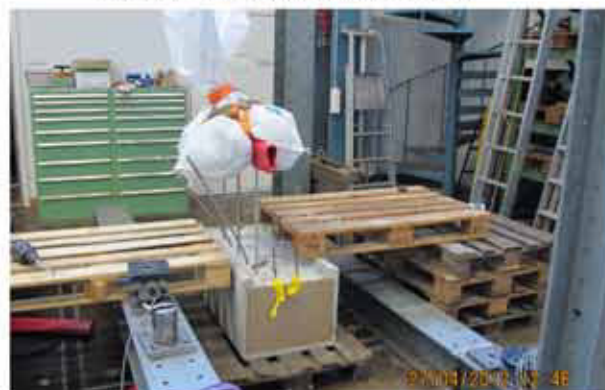
d) Test V03-14 (bar $\varnothing 14$ mm
and bar spacing 300 mm)

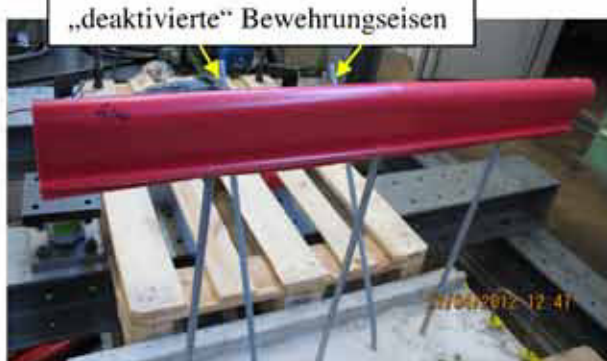
[Legend: „deaktivierte“ Bewehrungseisen:
“deactivated” reinforcement bars]

e) Test V03-14 (as in photo d)

Photo taken after removal of the sandbag

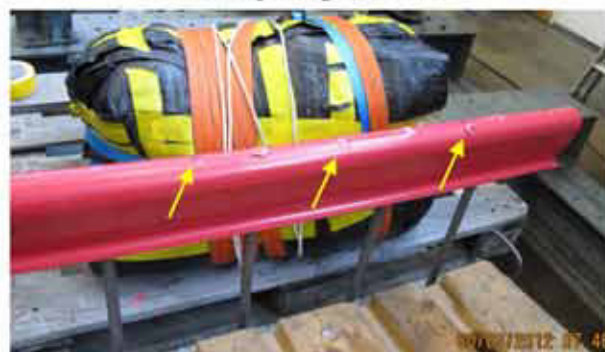
f) Tests V06-16 and V07-16 (bar $\varnothing 16$ mm)
with the same strip
Arrows show pressure points caused by test V06-16
